Ballistic Testing for Interceptor Body Armor Inserts Needs Improvement

August 1, 2011

SUBJECT: Ballistic Testing for Interceptor Body Armor Inserts Needs Improvement
(Report No. D-2011-088)

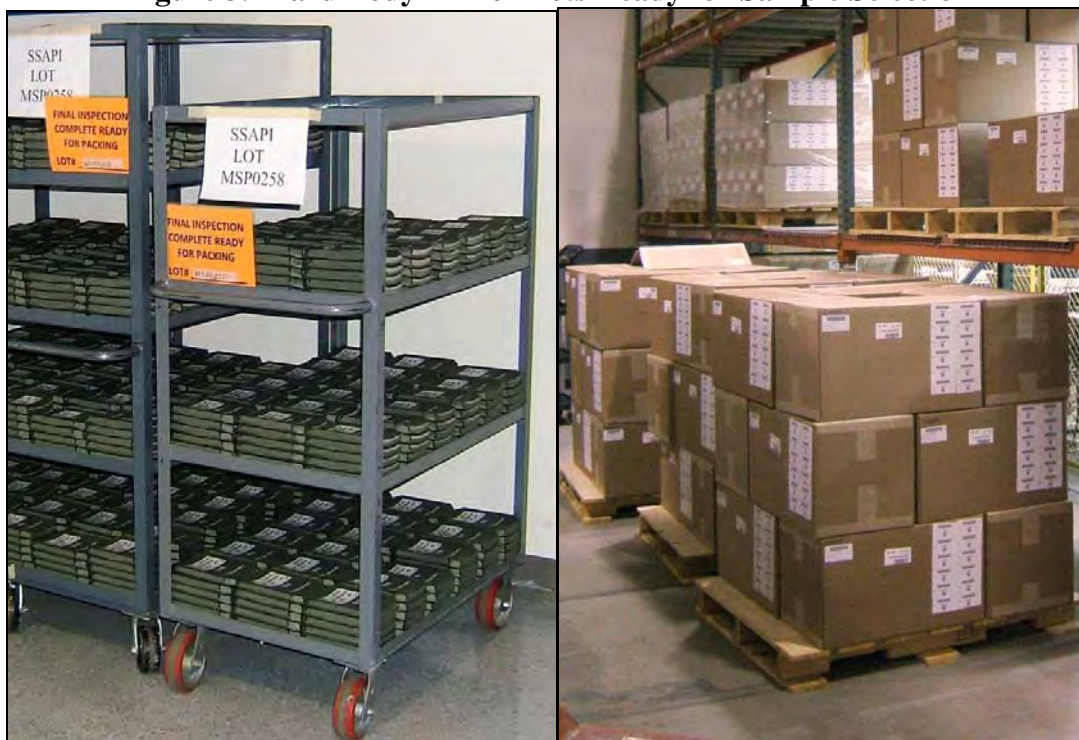
Figure 3. Hard Body Armor Lots Ready for Sample Selection

The QAR selects the samples and observes as a contractor employee verifies that weight and dimensions comply with contract requirements. The contractor employee records the serial numbers on the DD 1222, "Request for and Result of Tests," and the QAR signs it. The QAR then sends the samples and the DD 1222 to the applicable test lab for LATs.
